Trident™ System Foils Leak at Watts Corporate Headquarters

North Andover, Massachusetts

Wireless Sensor DT-502, Hub DT-501, Smart Base Station DT-550, and other components of The Detection Group® Trident™ System

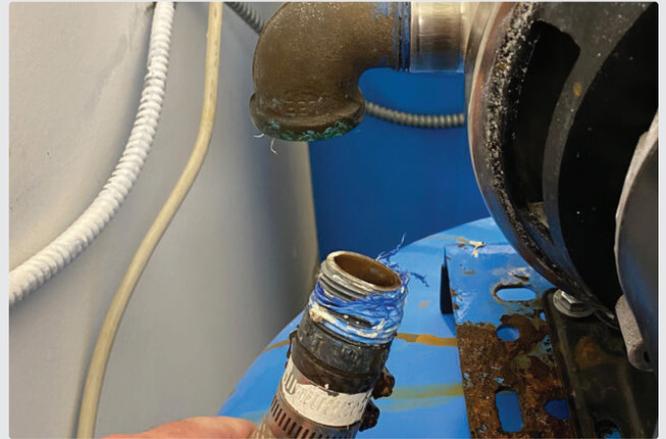
On 9/11/22, a typically quiet Sunday morning at Watts Corporate Headquarters, a water hose in the building's Irrigation Room disconnected. As soon as the break happened, water started flowing out—first into the Irrigation Room and then into a nearby Shipping & Receiving hallway. With no one around, it was on its way towards the carpeted space of the ground-floor offices, cubicles, and meeting rooms at the Watts North Andover, MA site.

A water hose in the building's Irrigation Room disconnected

The Watts Facilities team responded quickly to stop the leak and then got to work cleaning up the pooled water. “In the end, we had almost zero damage from the headquarters leak; we just had to replace a carpet in an office,” Brian said. “The entire ground floor could have been flooded if we hadn't gotten the call from the TDG system, and in preventing this, the TDG system has already paid for itself!”

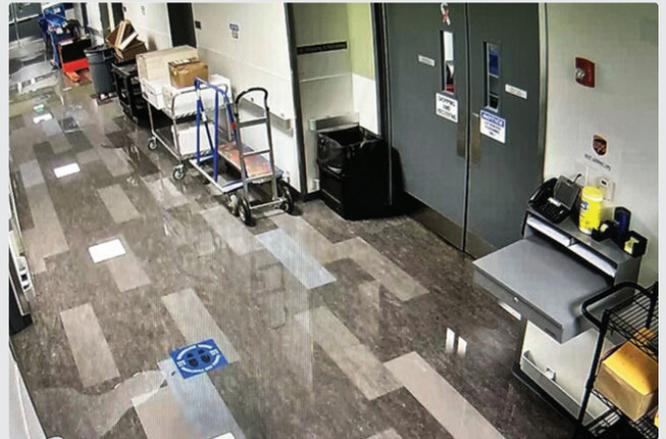
A wireless sensor adhered to a baseboard in the Shipping & Receiving hallway had detected the water seeping into the hallway and called in the alert. (Fifteen such sensors are positioned around the building and communicate back to three Hubs, one on each floor.) A Smart Base Station receives input from the Hubs, and can send out text, phone, and email alerts.

Water flowed into a nearby hallway
